Inspection and Gamma-Ray Dose Rate Measurements of the Annulus of the VSC-17 Concrete Spent Nuclear Fuel Storage Cask

**Idaho National Laboratory
Idaho Falls, Idaho 83415**

INL/EXT-07-13129

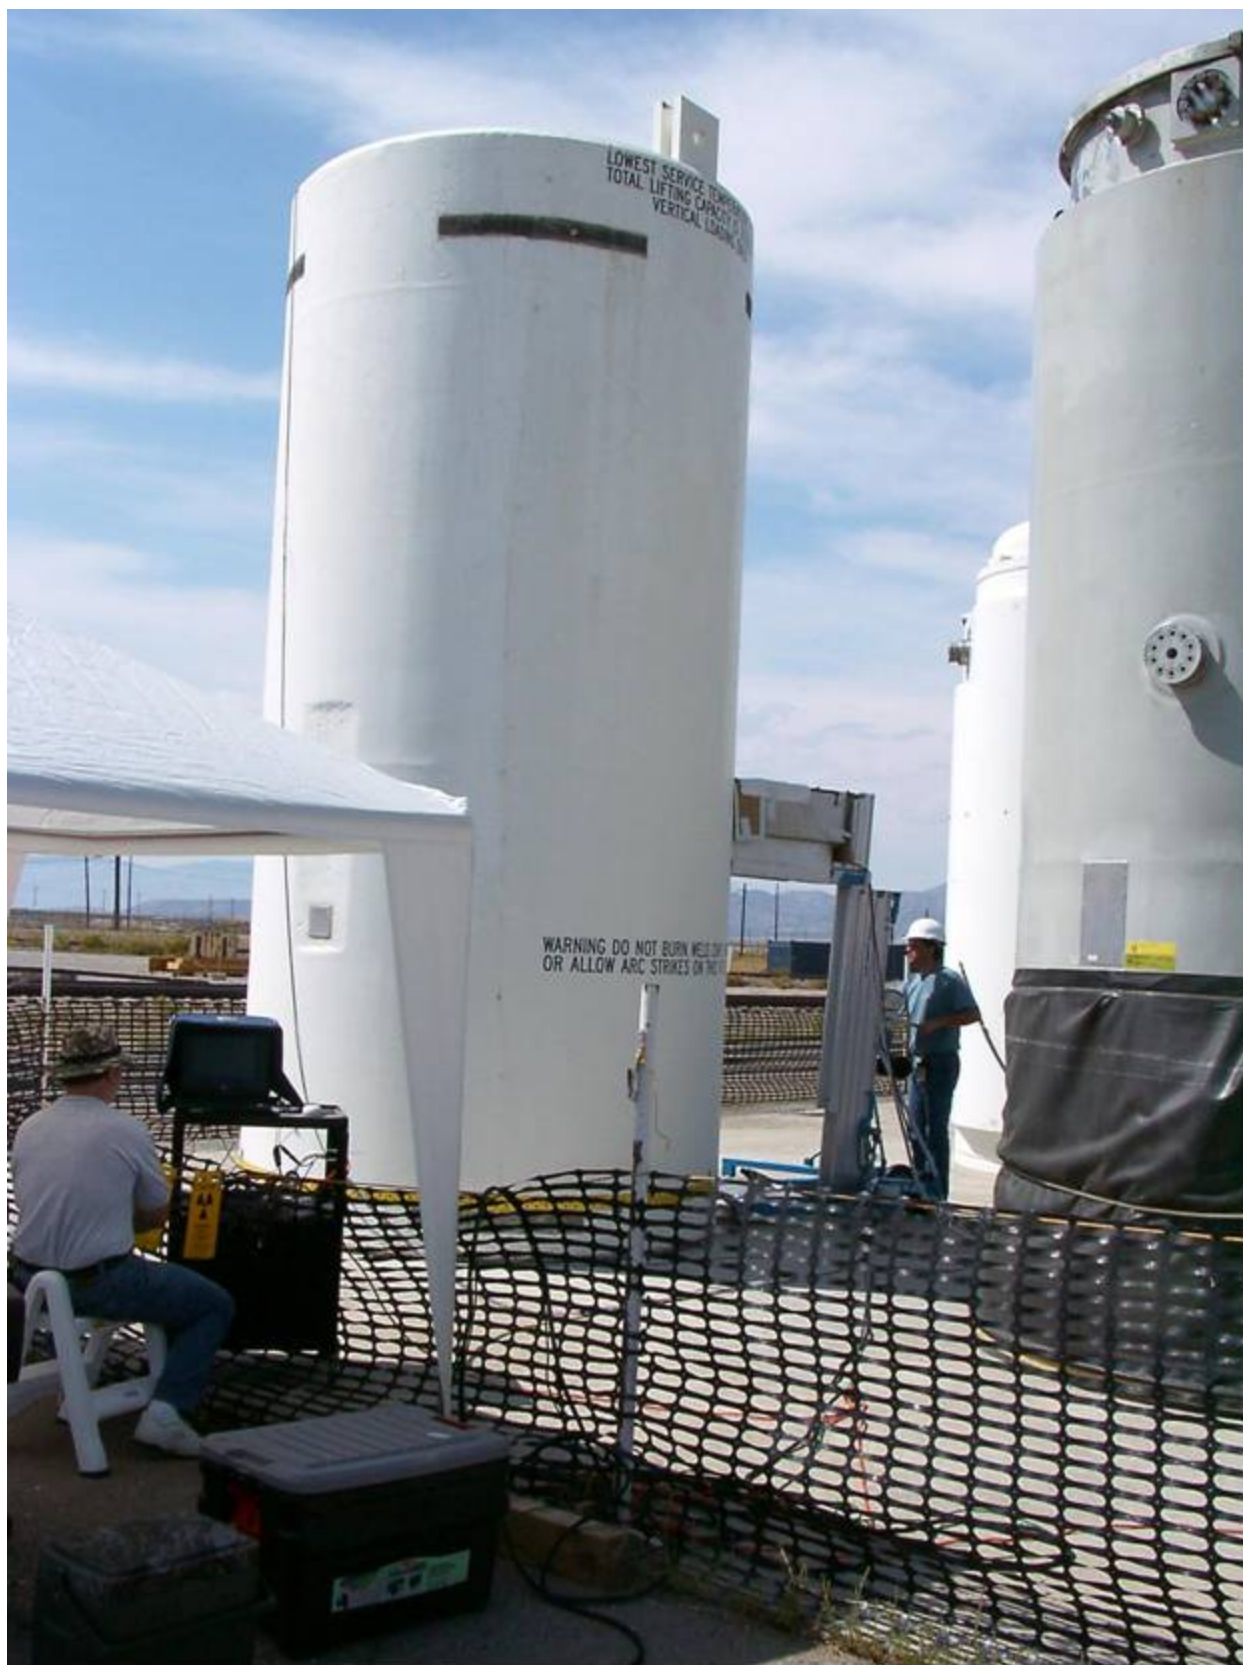
Figure 1. VSC-17 cask on TAN-791 pad September 2003.

The VSC-17 ventilated storage cask is a concrete-shielded SNF storage cask system that is designed to contain 17 pressurized water reactor (PWR) fuel elements. It consists of a central steel container, the multi-element sealed basket (MSB), surrounded by a vertical right circular annulus having a wall thickness of 20 in. of concrete. The inner liner of the VSC annulus is A-36 steel that is 89 mm (3.5 in.) thick, which provides structural support and additional shielding. The annular gap between the steel liner and the MSB is 76 mm (3 in.). Transfer of decay heat from the MSB occurs by convective airflow through vents in the concrete shielding component. The inner wall of the concrete shield annulus is steel, which provides structure and additional shielding. The VSC-17 is one of six casks originally stored on the TAN-791 pad at Test Area North (TAN) on the INL site in southeast Idaho. These casks were moved to the Idaho Nuclear Technology and Engineering Center (INTEC) CPP-2707 pad in 2004. The casks were originally assembled as a demonstration project to show the feasibility of dry storage of commercial SNF. The VSC-17 is a product of the Pacific Sierra Nuclear Company, which has since been assimilated into the British Nuclear Fuels plc (BNFL), Solutions Division. The design is unique in that it was scaled down from the commercially produced VSC-24 units. That scale-down was required by the physical limits of the INL cask mover, a six-wheeled straddle carrier that was used for moving the casks from the storage pad to the TAN Hot Shop for loading and maintenance. The cask mover can accommodate a maximum width of 267 cm (105 in.). An as-deployed image of the cask is shown in Figure 1. The upper vents are visible as dark horizontal strips approximately 50 cm (19.7 in.) below the square steel-plate lifting lug that is visible on the right of the top. The vent opening is screened to prevent access to debris or animals. A corresponding lower vent is partially visible through the storage area fence. As designed, the vents are arranged at 90-degree centers offset from the lifting fixtures. As shown in Figure 1, the cask is oriented with the lifting lugs along a north-south line, which is the same orientation as its position on the CPP-2707 pad.

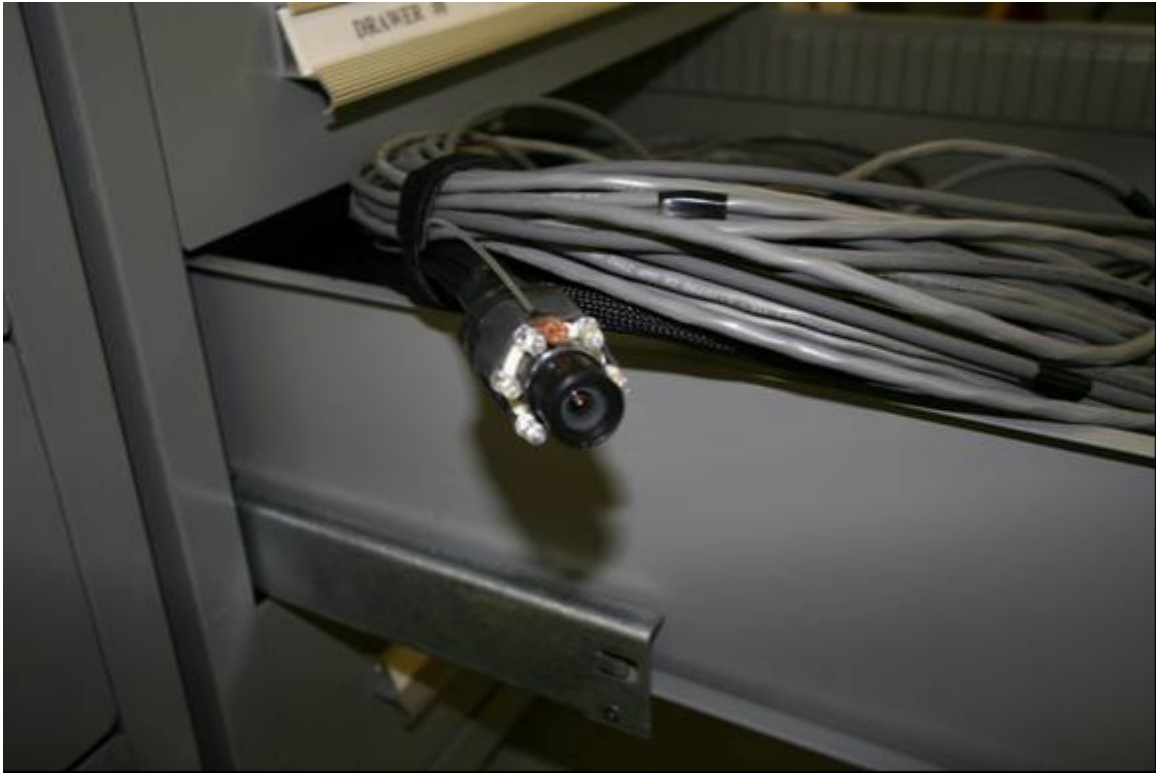
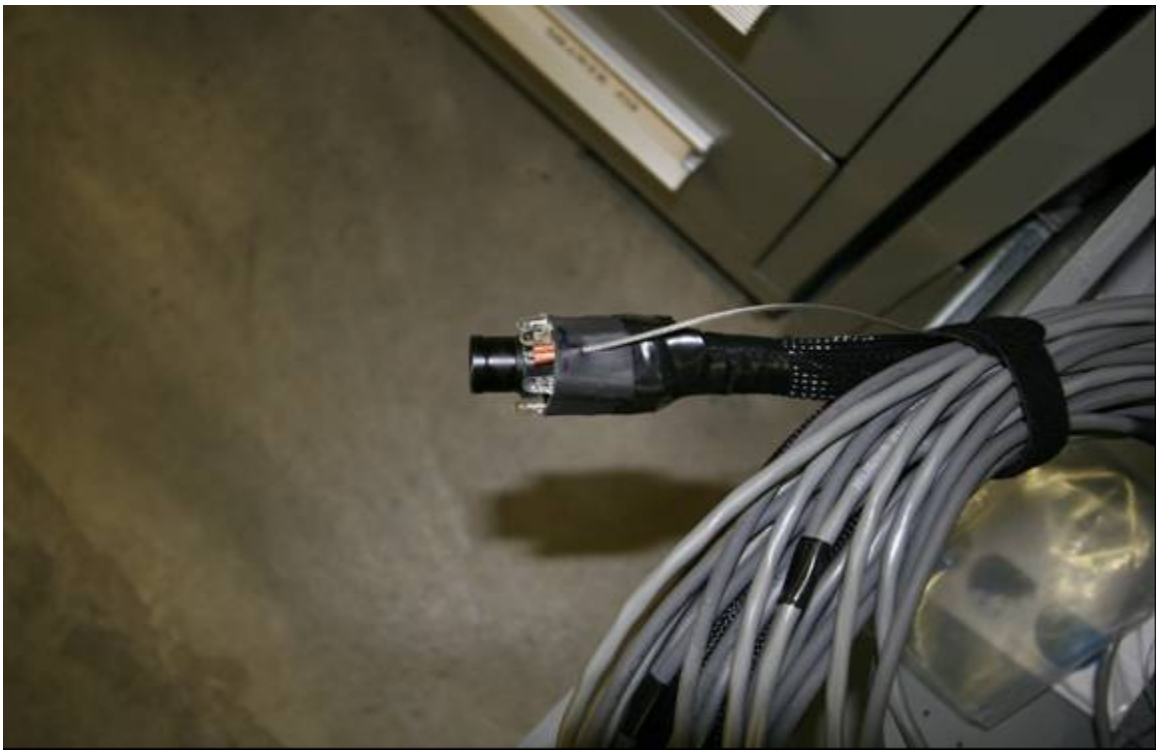
Figure 2. Toshiba video camera.

Annulus Video Inspection Comparison. Three different cameras were used to inspect the annulus of the VSC-17 cask. Data sheets for the cameras are shown in Appendix A. The first camera used in March 2004 to inspect the annulus was a Toshiba Model EM-QN42H camera with a 4-mm lens. This camera is shown in Figures 2 and 3.

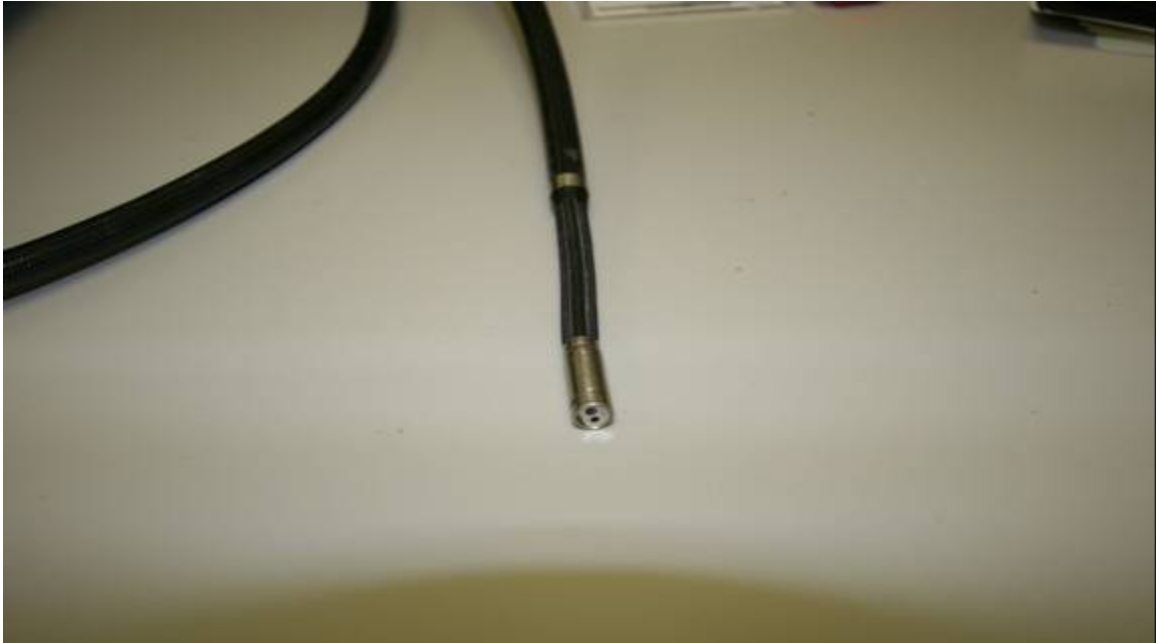
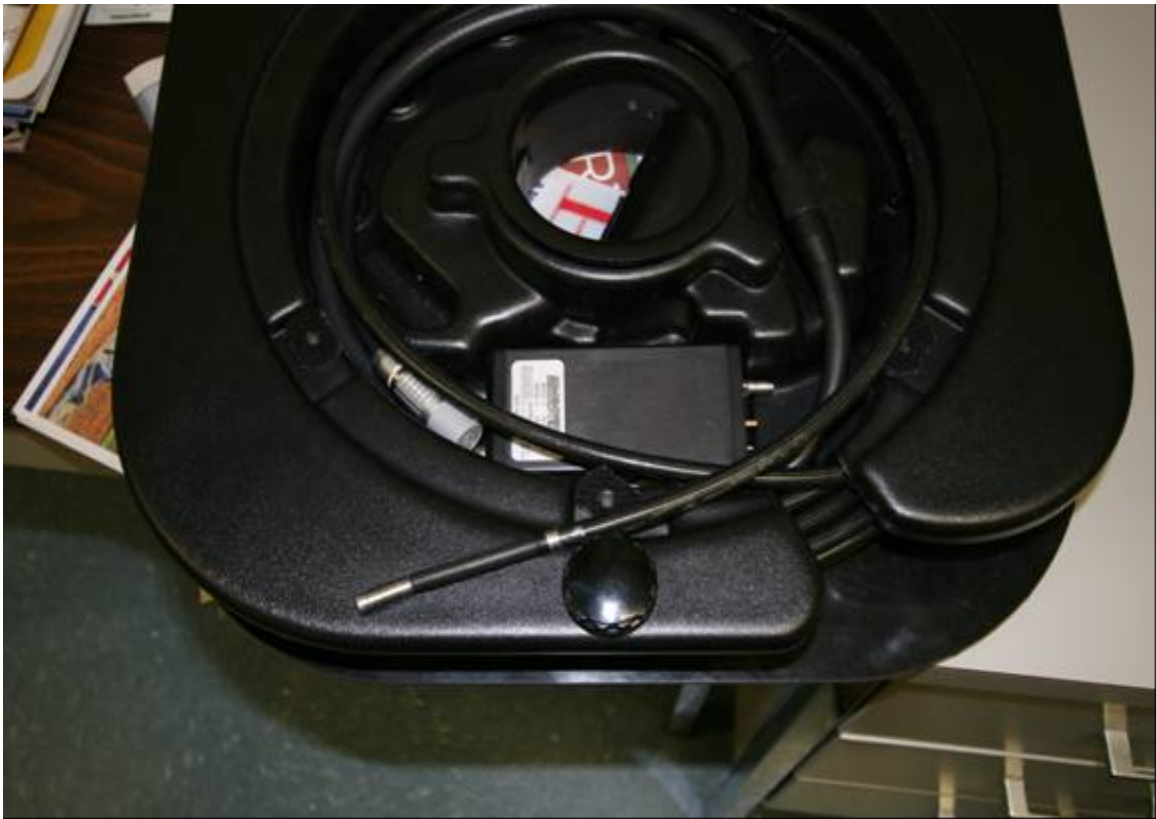
Figure 4. Everest/VIT borescope camera.

In September 2004, the camera used to inspect the annulus was an EVEREST/VIT XLPro video probe with an XLC 1000 SYS Probe and a PXT850SG lens that has a 50-degree field of view and 9–160 mm depth of field. This camera is shown in Figures 4 and 5.

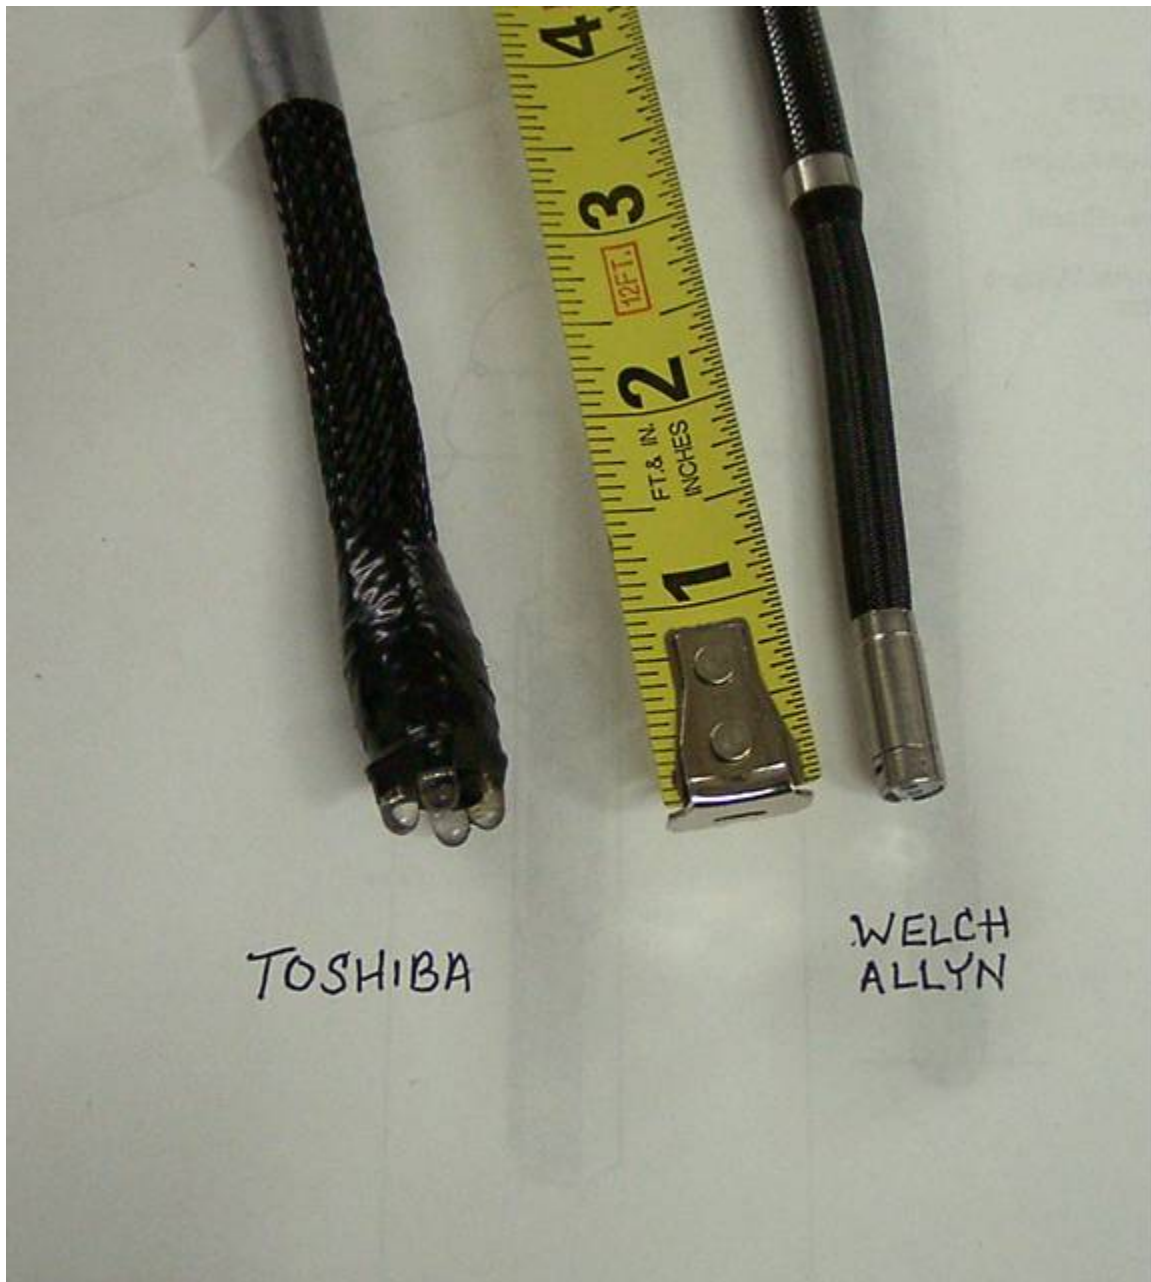
Figure 6. Toshiba Model EM-QN42H and Everest/VIT borescope cameras compared.

In March 2007, at the request of CRIEPI, a Toshiba Model IK-M44H with a 7.5-mm lens was used to perform the annulus inspection. This camera is shown in Figure 6.

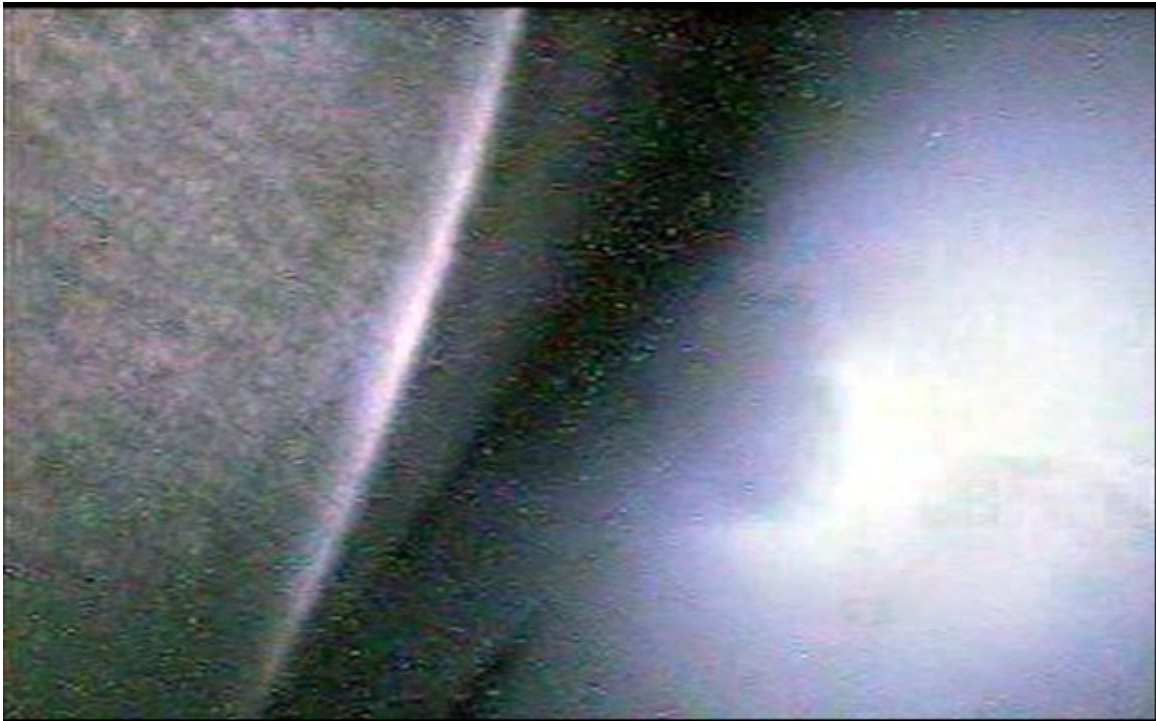
Figure 7. Upper annulus.

To provide a visual indication of the comparative effectiveness of the cameras, still images taken from the video acquisition are shown below. These images are of approximately similar locations within the annulus, one located near a weld near the top of the MSB, and one near the bottom of the MSB. See Figures 7 through 12.

Toshiba EM-QN42H camera images, March 2004.

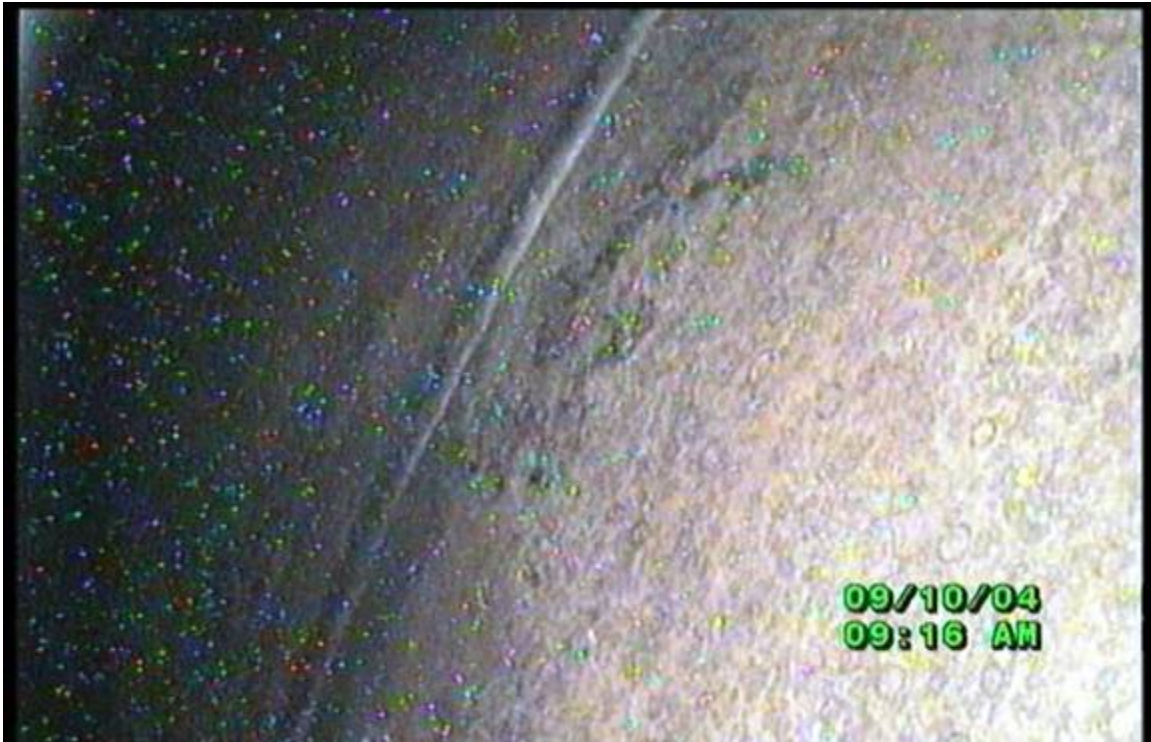
Figure 9. Upper annulus.

Welch Allyn Everest/VIT borescope images, September 2004.

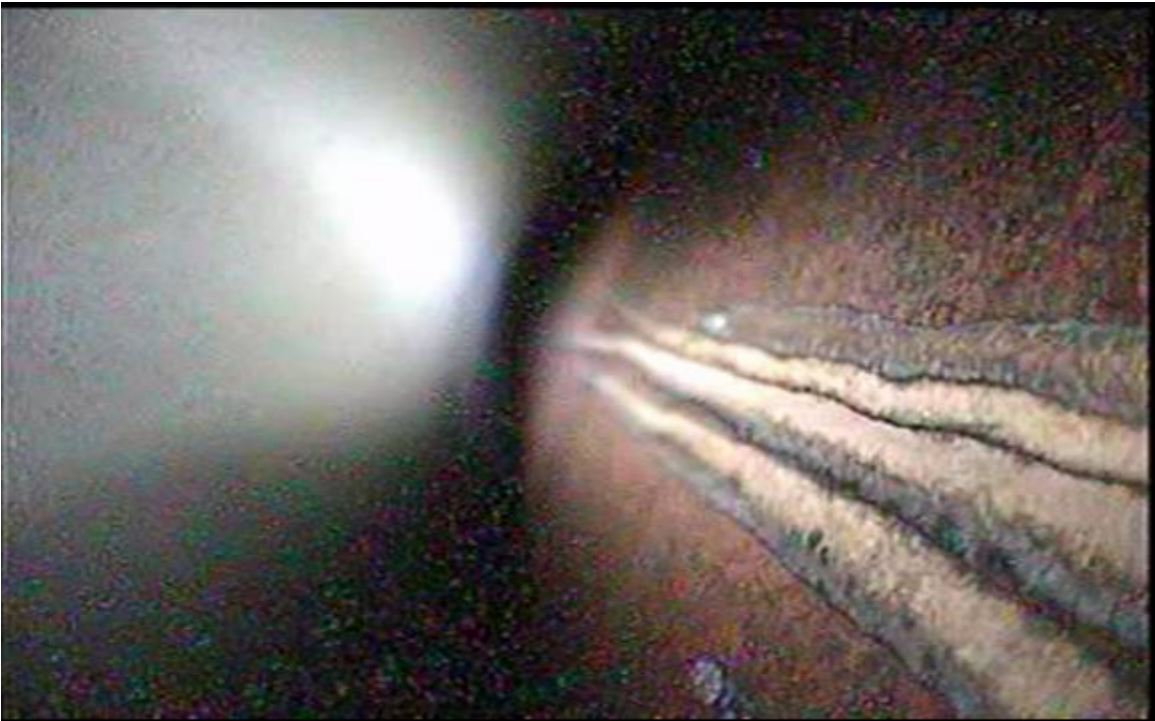
The video of the inspection is attached to this report. No detectable changes have occurred between 2004 and 2007. The only indications of degradation of the external surface of the MSB are some rust stains that appear to be the result of water, either wind-blown or condensed, running down the side of the steel basket.

Figure 11. Upper annulus showing condensation stains on multi-element sealed basket (MSB).
